Manhole Inspection Summary

Manhole # S31AA2003MH

Insp Date: **4/16/07 12:38 PM**

Location Address: **111 TAPLOW RD**

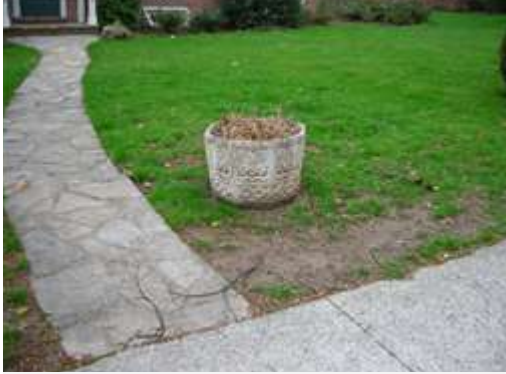
Location View

Comments **Plant pot on top of manhole.**

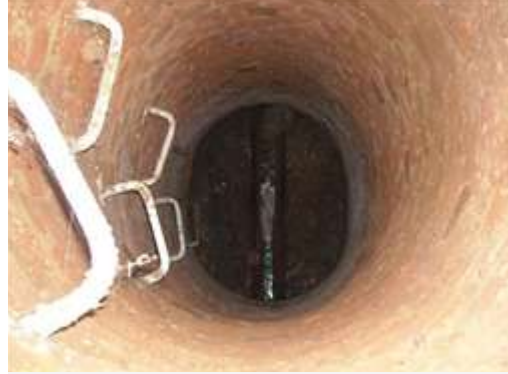
Top View

Barrel infiltration. Corroded steps.
Evidence of surcharge - Bench debris.
Channel debris.

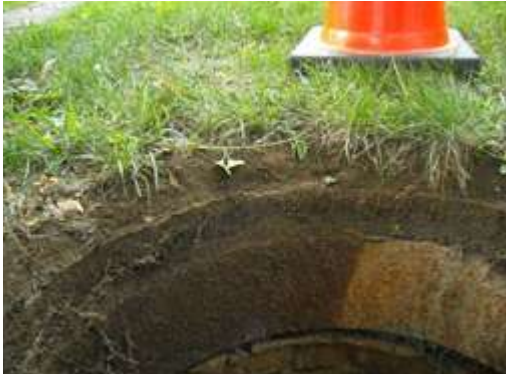
Defect

Below grade. Frame leaks.

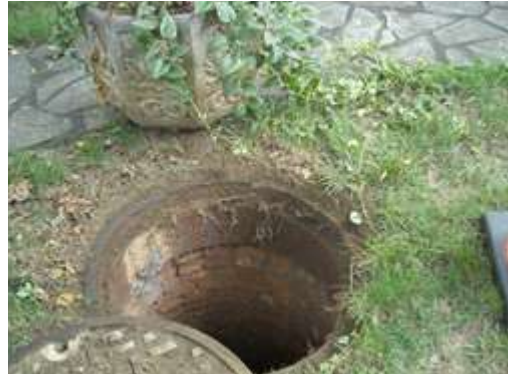
Defect

Frame leaks. Corbel deterioration and
infiltration.

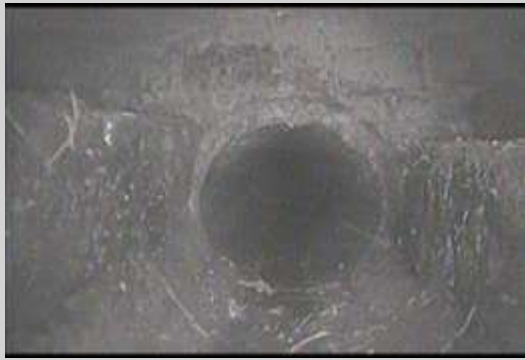
8 in. Circular Gravity Sewer Pipe Out @ 12 O'Clock

Invert Depth: **12.18** (ft.) Flow Characteristics: **Slow**

Infiltration: **None** Pipe Seal Cond: **Unknown**

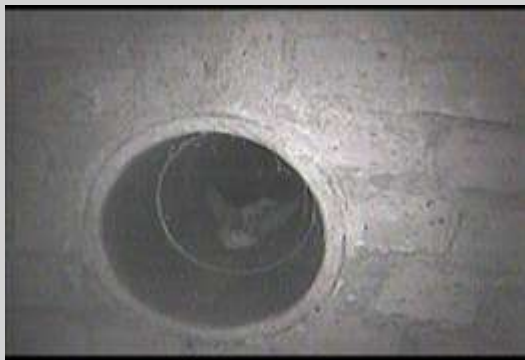
8 in. Circular Gravity Sewer Pipe In @ 6 O'Clock

Invert Depth: **9.76** (ft.) Flow Characteristics: **Slow**

Infiltration: **Evidence** Pipe Seal Cond: **Cracked**

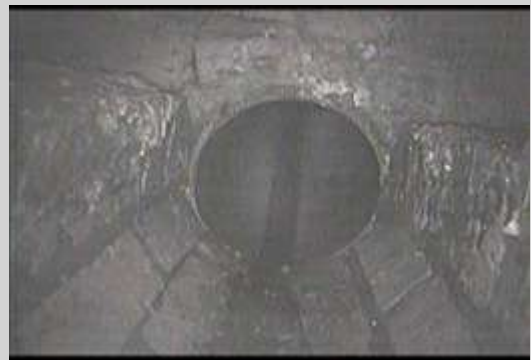
Drop In @ 6 O'Clock

Drop: **Outside** Rod and Bar

Drop Condition: **Open**
